# **CYNGOR GWYNEDD**

## **YSGOL TREFERTHYR: BAT EMERGENCE SURVEYS**

**Dr Rod Gritten PhD PGCE CBiol MSB  
GRITTEN ECOLOGY**

**20<sup>th</sup> May 2021**

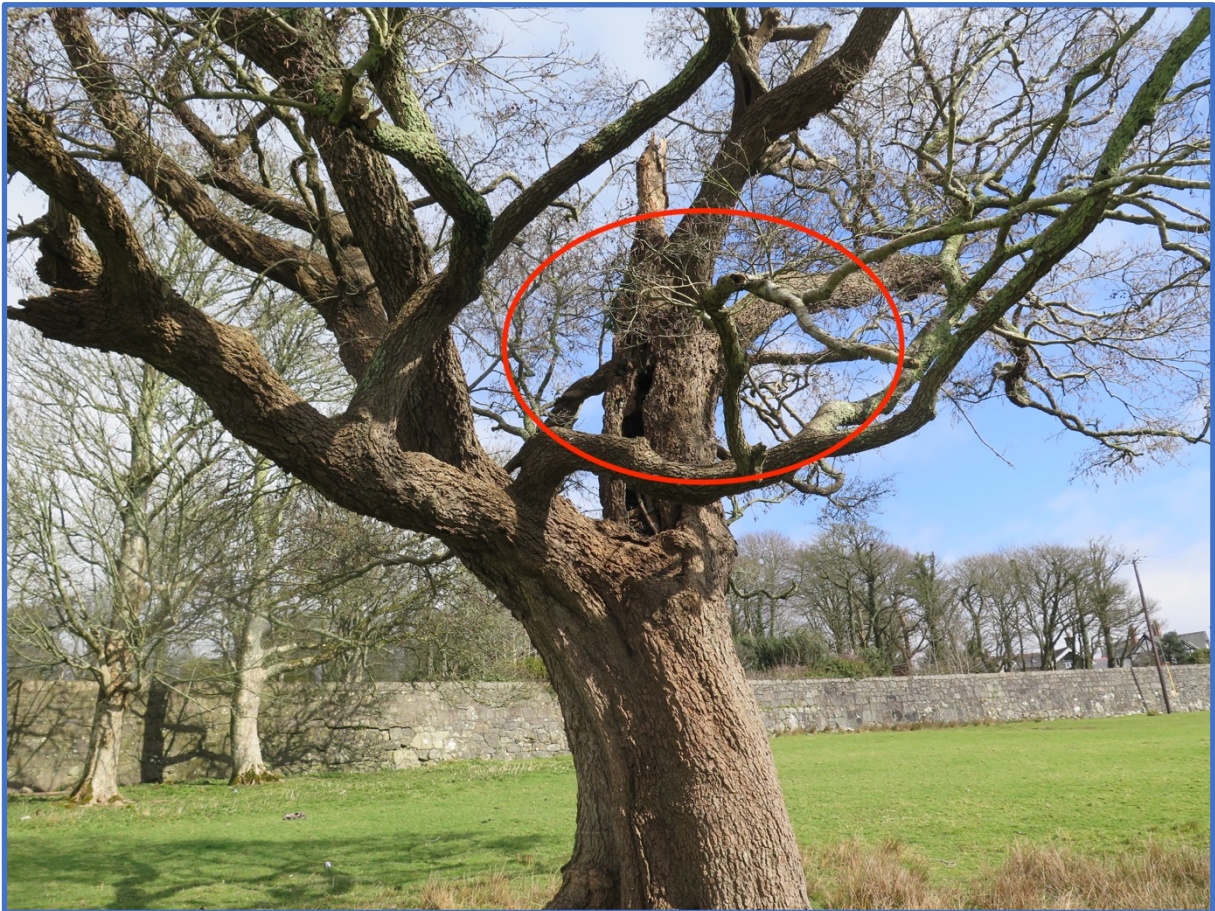
**Tree No. 4 (0059)** is a veteran Alder (*Alnus glutinosa*) (**Photo 1**) that has High Potential (4) as a bat roost. It has been recommended to be felled to accommodate the proposed development. It has suitable hollows and fissures to the west. One surveyor was stationed to the west during the 17.5.21 emergence survey. An endoscope survey was also carried out on 1.4.21 using a telescopic ladder for access and a General 5660 Seascope endoscope. No signs of bats were noted during that survey indicating the tree was not being used as a hibernaculum. **No bats were seen to be emerging** during the survey.

**Photo 1: The veteran Alder with the potential bat roost ringed in red.**
