**BS: 5837/2012. Tree Impact Assessment. – Ysgol Treferythyr Criccieth, field south of the A497, Llanystumdwy, Criccieth, Gwynedd, Wales, LL52 0RY.**

**Report Prepared By: L O'Connor BSc (Hons), MSc.**

**18/05/2021.**

## **TREE IMPACT ASESMENT. (T.I.A.).**

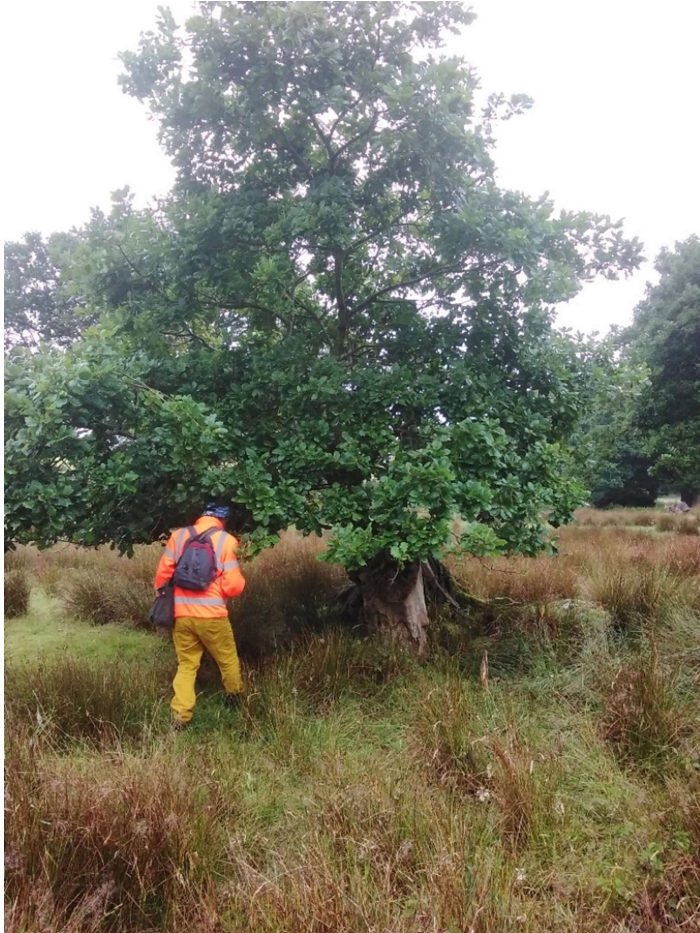
Tree No	Tag No	Species	Height (M)	DBH (CM)	Crown Spread	Age Class	Condition	Recommendations	Work Priority	SULE Yrs	BS5837 m2 and r.	BS 5837 Retention category.
T1	0056	Sessile oak.  <i>Qp.</i>	6	220	N: 2 E: 4 S: 2 W: 2	OM vet	<b>Poor, coppiced.</b>  <b>Buds and twigs:</b> Good.  <b>Scaffold:</b> Good.  <b>Stem:</b> Poor, coppice on old veteran stool, cambium peeling throughout, decay on 2 x large removed old branches, boot lacing present E @0.4m  <b>Roots:</b> Poor <b>Am</b> infection and advanced decay throughout.	<b>Retain.</b>  Protective fence in accordance with BS:5837/2012. See <b>FIG.TCM.APP.9.</b>  RZ offset to the NE by irrigation ditching.  <b>Important veteran tree very old.</b>	<b>HIGH</b>	80 - 100	<b>26.4</b>  <b>2189.56</b> <b>4416.</b>	<b>A2</b>

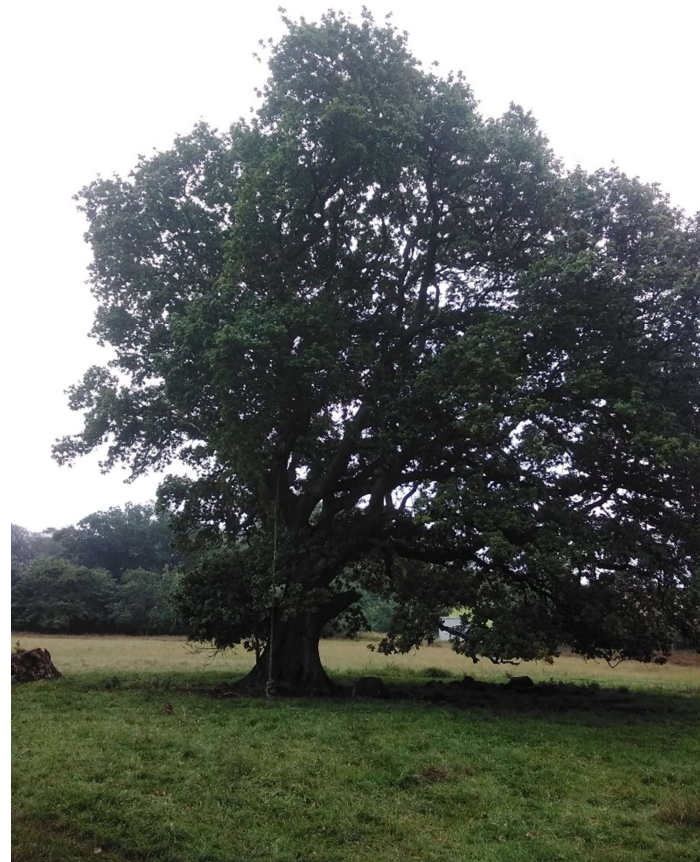
Tree No	Tag No	Species	Height (M)	DBH (CM)	Crown Spread	Age Class	Condition	Recommendations	Work Priority	SULE Yrs	BS5837 m2 and r.	BS 5837 Retention category.
T2	0057	Sessile oak.  <i>Qp.</i>	14	123	N: 10 E: 8 S: 10 W: 10	OM vet	<p><b>Poor:</b></p> <p><b>Buds and twigs:</b> Fair.</p> <p><b>Scaffold:</b> Fair, major deadwood throughout, large tearouts with decay, hazard beam developing S@10m, water and decay in main branch junction @4m from old tearout.</p> <p><b>Stem:</b> Poor, occluded pruning wounds throughout, <i>Ganoderma</i> SE@0m and within trunk E@0m, likely major hollowing throughout lower part of stem.</p> <p><b>Roots:</b> Fair good reactive buttressing throughout, upper part of roots affected by <i>Ganoderma</i>.</p>	<p><b>Retain veteran tree.</b></p> <p>Remove large limb S with hazard beam by 6 to 7 meters to appropriate branch leader.</p> <p><b>Important veteran tree very old.</b></p> <p>Protective fence in accordance with BS:5837/2012. See <b>FIG.TCM.APP.9.</b></p>	<b>HIGH</b>	80 - 100	<p><b>14.76</b></p> <p><b>684.419</b></p> <p><b>8357</b></p>	<b>A2</b>

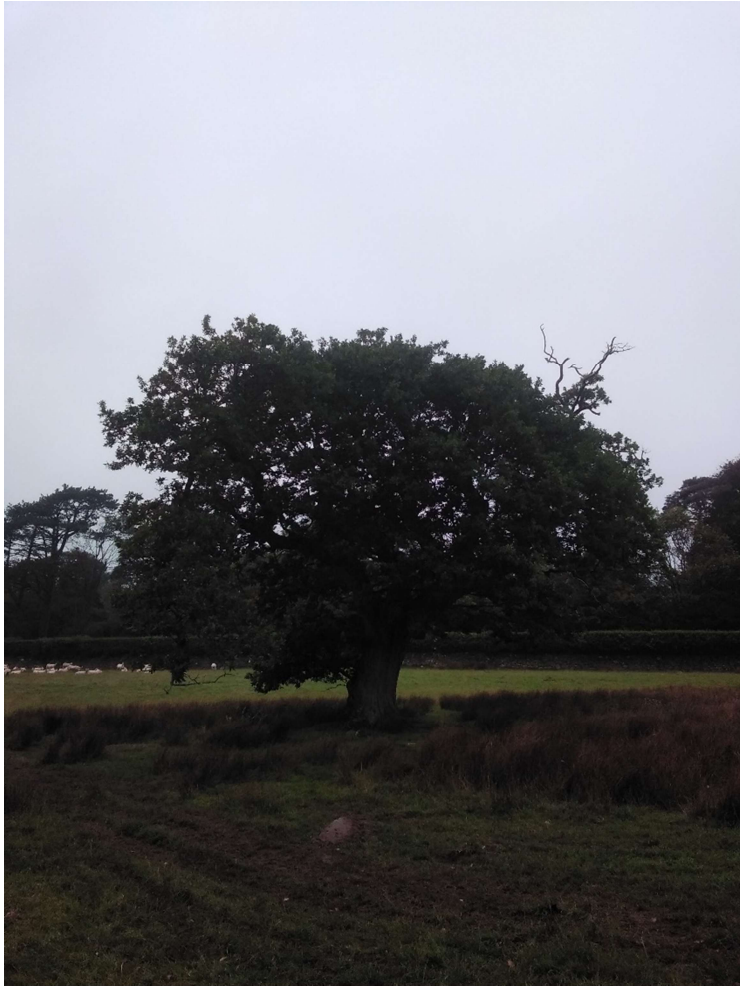
**T3**

Tree No	Tag No	Species	Height (M)	DBH (CM)	Crown Spread	Age Class	Condition	Recommendations	Work Priority	SULE Yrs	BS5837 m2 and r.	BS 5837 Retention category.
T3	0058	Sessile oak.  <i>Qp.</i>	20	147	N: 10 E: 15 S: 12 W: 10	Om vet	<p><b>Fair:</b></p> <p><b>Buds and twigs:</b> Good.</p> <p><b>Scaffold:</b> Good, major deadwood throughout crown, large tear out E@10m and S@3m, large rubbing limbs S@7m, hazard beam developing W@8m.</p> <p><b>Stem:</b> Poor, huge cavity E from 0-2m measuring 1m across extending 1m into tree, small <i>Ganoderma</i> fruiting body present E@1m, old stone wall incorporated into stem.</p> <p><b>Roots:</b> Fair, good reactive buttressing, some compaction in rooting zone from historic livestock use.</p>	<p><b>Retain and monitor.</b></p> <p>Remove dead wood.</p> <p><b>Important veteran tree very old.</b></p> <p>Protective fence in accordance with BS:5837/2012. See <b>FIG.TCM.APP.9.</b></p>	<b>HIGH</b>	60-80	<p><b>17.64</b></p> <p><b>977.568</b></p> <p><b>1294</b></p>	<b>A2</b>

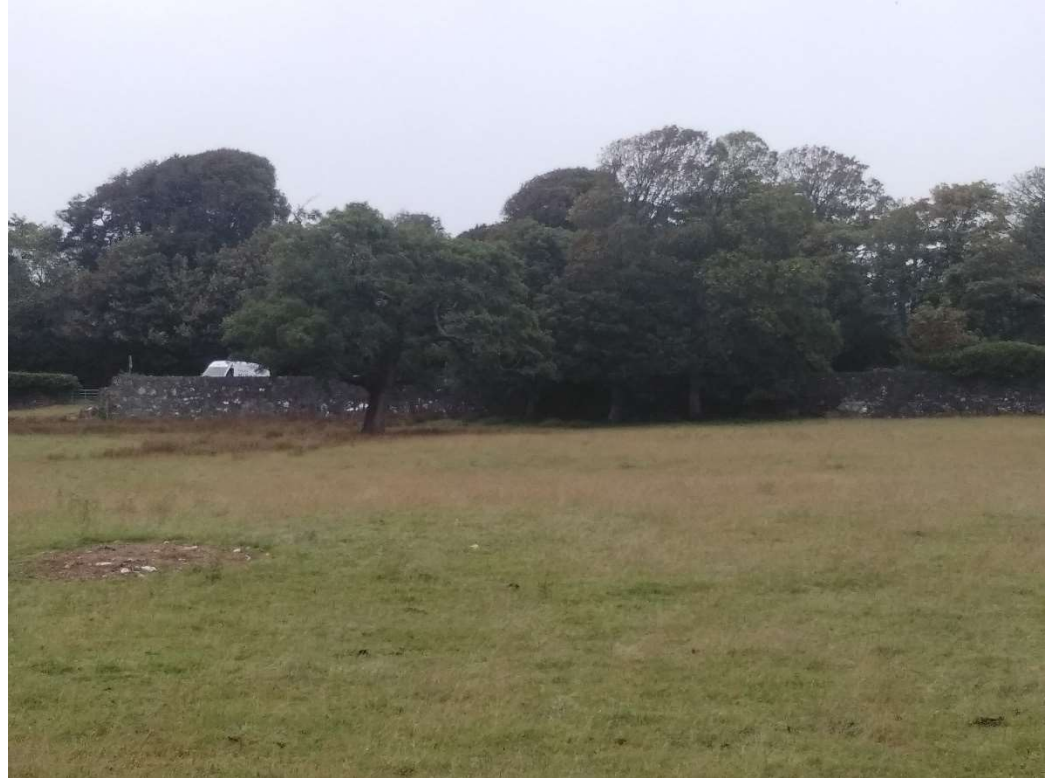
**T4,T5,T6,T7**

Tree No	Tag No	Species	Height (M)	DBH (CM)	Crown Spread	Age Class	Condition	Recommendations	Work Priority	SULE Yrs	BS5837 m2 and r.	BS 5837 Retention category.
T4	0059	Alder  <i>Ag.</i>	11	104	N: 10 E: 10 S: 8 W: 10	OM-Vet	<p><b>Fair:</b></p> <p><b>Buds and twigs:</b> Fair.</p> <p><b>Scaffold:</b> Fair, major deadwood throughout, tearout on major co-dominant E from 6-8m with large longitudinal cavitation from 3-6m at least 50cm in diameter t/r ratio of co - dominant compromised.</p> <p><b>Stem:</b> Good, possible <i>am</i> infection.</p> <p><b>Roots:</b> Good, good reactive buttressing.</p>	<p>Tree to be felled to facilitate development.</p> <p>Ancient tree for species.</p> <p>Tree loss to be mitigated by additional planting as per landscaping prepared by Lingard Styles.</p>	HIGH	60 - 80	<p>12.48</p> <p>489.304</p> <p>3124</p>	U

Tree No	Tag No	Species	Height (M)	DBH (CM)	Crown Spread	Age Class	Condition	Recommendations	Work Priority	SULE Yrs	BS5837 m2 and r.	BS 5837 Retention category.
T5	0060	Sycamore  <i>Ap.</i>	14	64	N: 10 E: 5 S: 8 W: 8	M	<p><b>Poor:</b></p> <p><b>Buds and twigs:</b> Fair.</p> <p><b>Scaffold:</b> Poor, major deadwood throughout, central crown rotted out from large past tear out, large co-dominant N over parking area high possibility of failure.</p> <p><b>Stem:</b> Poor, huge cavity and decay from 0-5m t/r ratio compromised, boot lacing present. <b>Am</b> infection.</p> <p><b>Roots:</b> Poor.</p>	<p><b>FELL on condition and replant.</b></p> <p>Tree loss to be mitigated by additional planting as per landscaping prepared by Lingard Styles.</p>	HIGH	0 - 20	<p><b>7.68</b></p> <p><b>185.298</b></p> <p><b>6745</b></p>	<b>U</b>

Tree No	Tag No	Species	Height (M)	DBH (CM)	Crown Spread	Age Class	Condition	Recommendations	Work Priority	SULE Yrs	BS5837 m2 and r.	BS 5837 Retention category.
T6	0061	Sycamore  <i>Ap.</i>	18	64	N: 8 E: 6 S: 8 W: 5	M	<b>Good.</b>  <b>Buds and twigs:</b> Fair, some signs of minor crown dieback.  <b>Scaffold:</b> Good.  <b>Stem:</b> Good, minor cavities throughout stem from old pruning wounds.  <b>Roots:</b> Good.	<b>Retain.</b>  <b>NWR.</b>  Protective fence in accordance with BS:5837/2012. See <b>FIG.TCM.APP.9.</b>	<b>NWR</b>	60-80	<b>7.68</b>  <b>185.298</b> <b>6745</b>	<b>A2</b>

Tree No	Tag No	Species	Height (M)	DBH (CM)	Crown Spread	Age Class	Condition	Recommendations	Work Priority	SULE Yrs	BS5837 m2 and r.	BS 5837 Retention category.
T7	0062	Sycamore  <i>Ap.</i>	18	56	N: 8 E: 10 S: 10 W: 5	M	<b>Good:</b>  <b>Buds and twigs:</b> Good.  <b>Scaffold:</b> Good, dying branch W@6m.  <b>Stem:</b> Good.  <b>Roots:</b> Good.	<b>Retain.</b>  Removing dying branch W @6m.  Protective fence in accordance with BS:5837/2012. See <b>FIG.TCM.APP.9.</b>	<b>HIGH</b>	80-100	<b>6.72</b>  <b>141.869</b> <b>2977</b>	<b>A2</b>

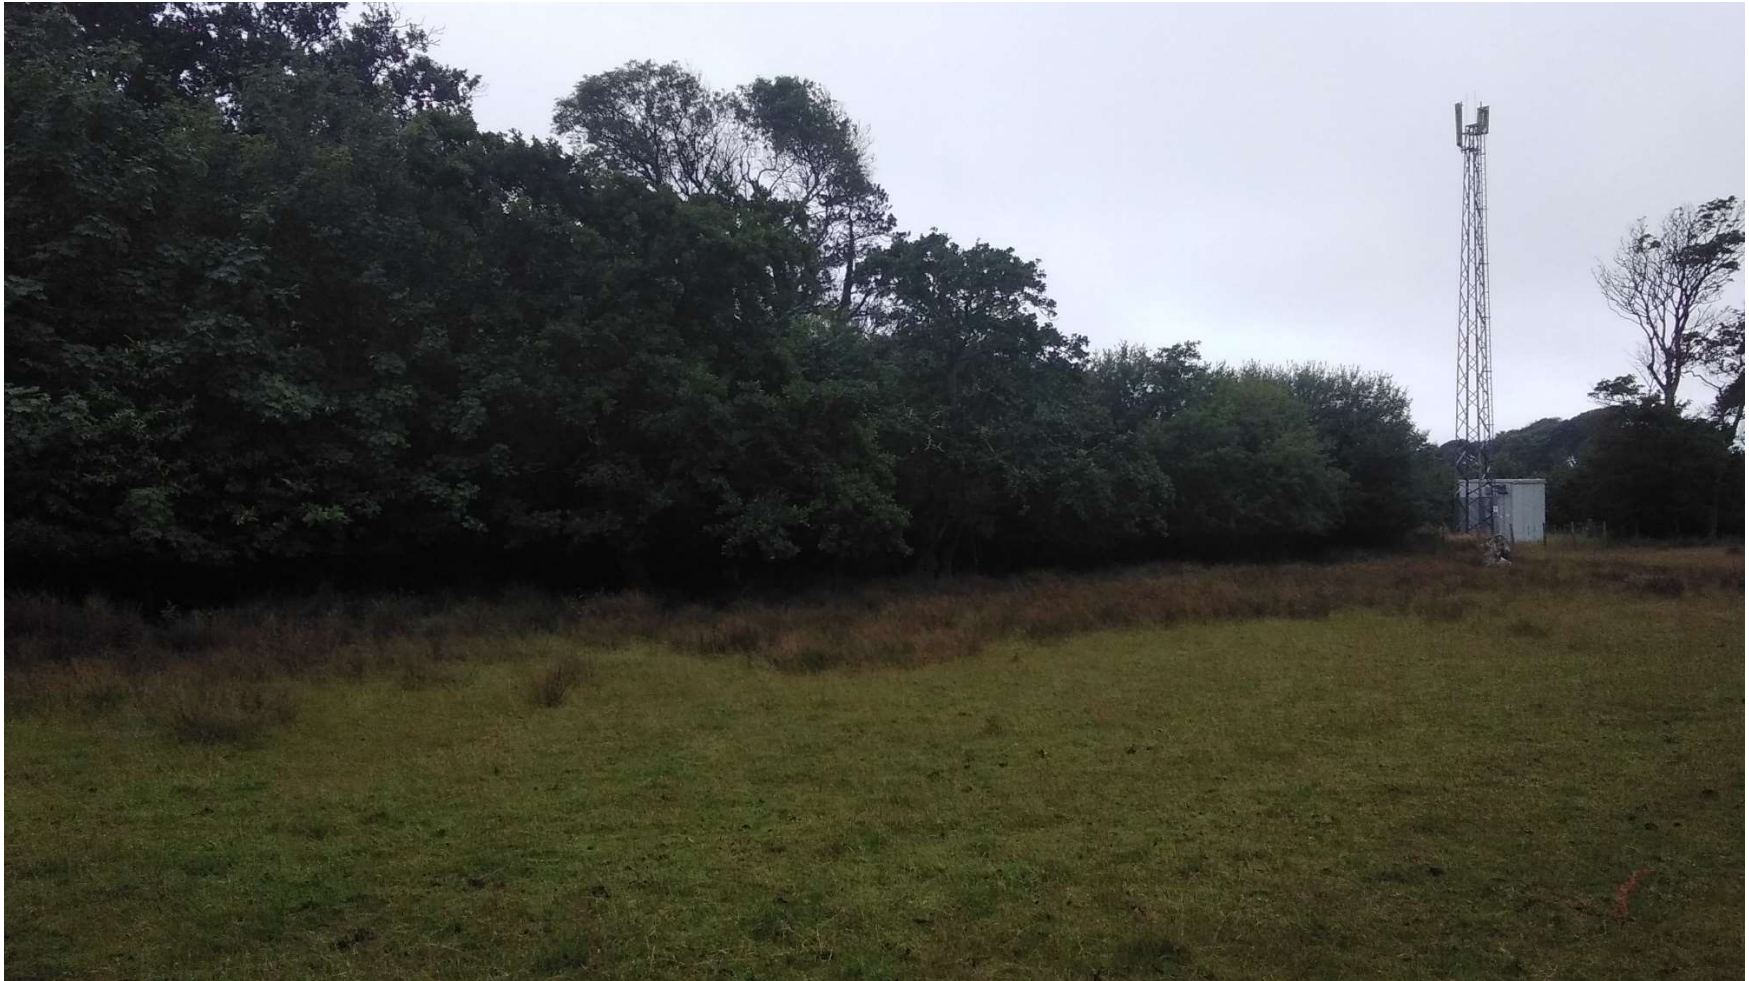
Tree No	Tag No	Species	Height (M)	DBH (CM)	Crown Spread	Age Class	Condition	Recommendations	Work Priority	SULE Yrs	BS5837 m2 and r.	BS 5837 Retention category.
H1	N/A	Ash, <i>Fe.</i>  Sycamore, <i>Ap.</i>  Sessile Oak, <i>Qp.</i>  Willow, <i>Sc.</i>  Laurel, <i>Ln.</i>  Alder, <i>Ag.</i>	10av	10, 22,1 6,25, 32,2 5,4,8 ,30,1 6	N: E: S: W:	M	<b>Good.</b>  Buds and twigs: Good.  Scaffold: Good.  Stem: Good.  Roots: Good.	Retain.  <b>NWR.</b>  Protective fence in accordance with BS:5837/2012. See <b>FIG.TCM.APP.9.</b>	<b>NWR</b>	80-100	<b>3.6</b>  <b>40.7150</b>  <b>4079</b>	<b>A2</b>

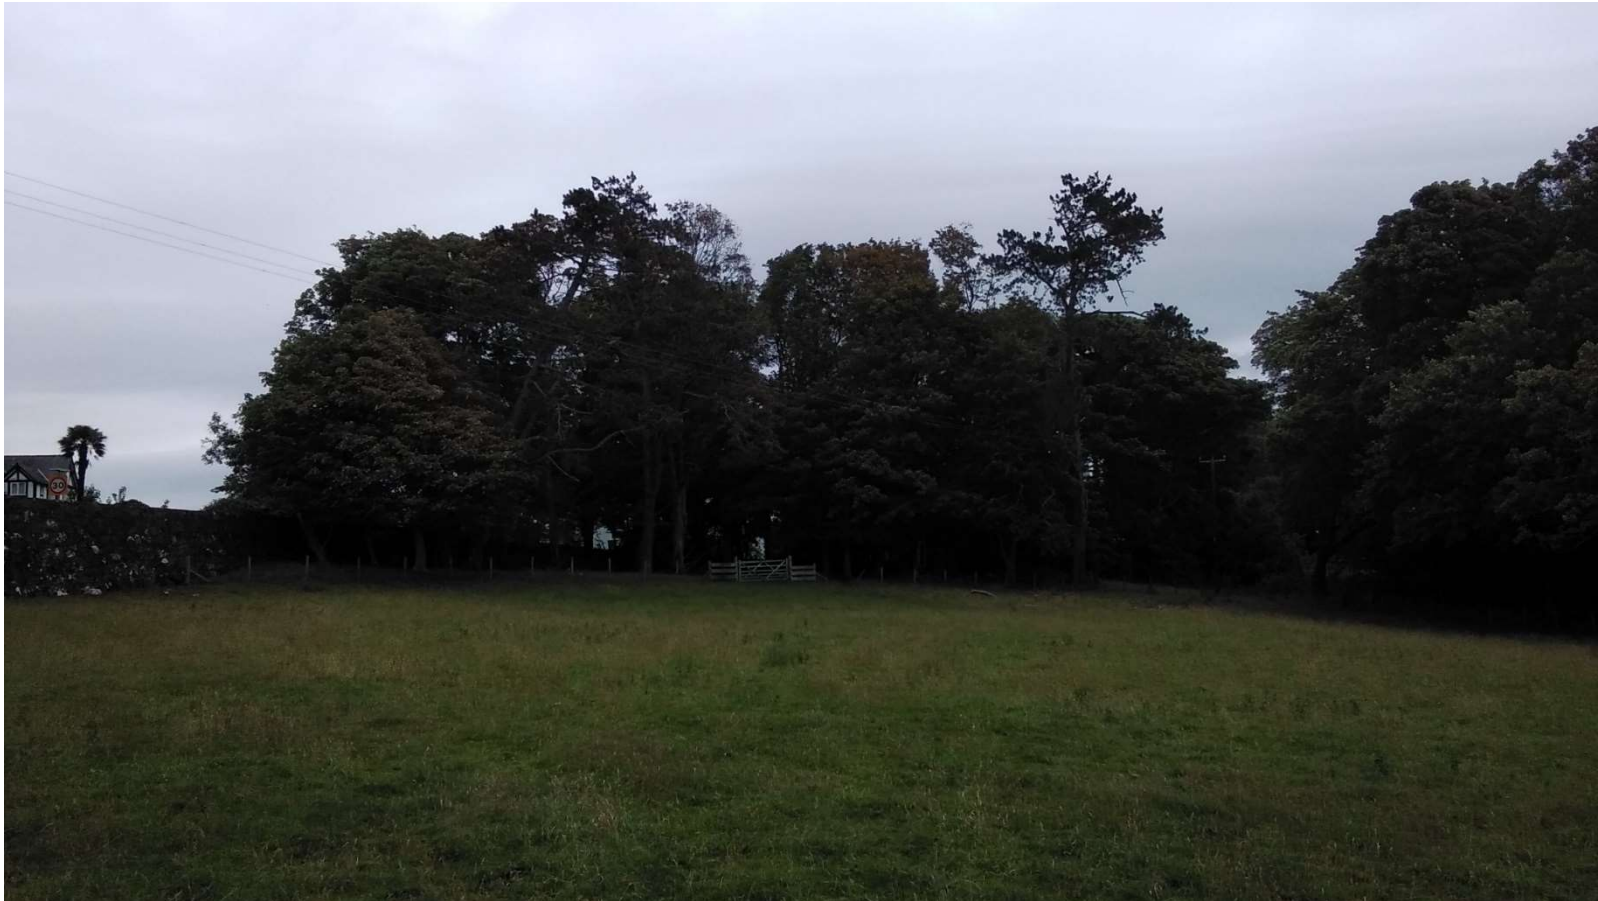
**T13, T15, T17, T21, T22, T29, T32, T34, T35, T37, T38, T39, T59 & G1 located to the far east of the site are to be removed.** The trees have been identified for removal due to poor condition and or defects. Please see schedule 2.1 for condition details.

Easterly stand of trees including G1, looking from the west. Poor condition trees to be removed as per schedule. 2.1. Retained trees to be protected in accordance with BS:5837/2012 and stand to be beaten up with additional planting to mitigate tree removals. Area includes trees T8-T41, T57, T58, T59

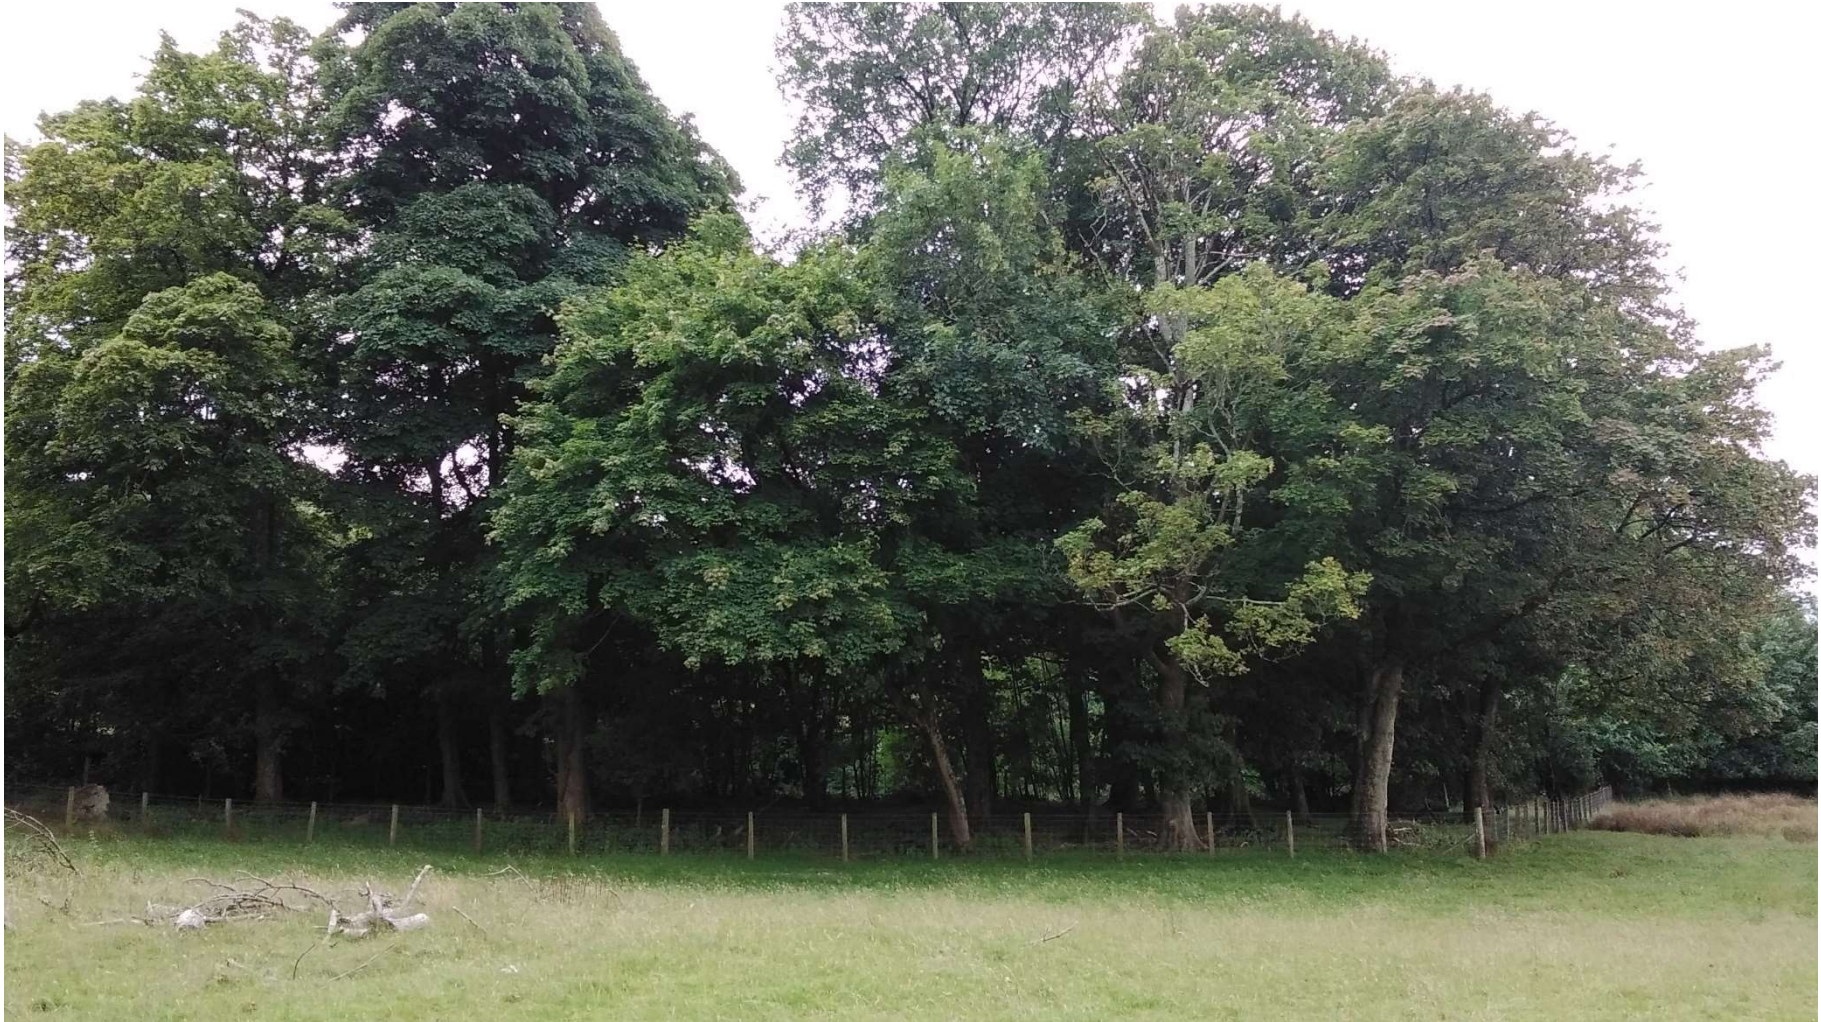
**T42, T43, T44, T45, T47, T48, T49, T50** Are to be retained and are situated within **G2** at the south of the site. These trees are classified as **BS: 5837/2012 Category A and B trees.** These trees are to be protected during construction with protective fencing in accordance with BS:5837/2012. Tree works should be carried out in accordance with the schedule 2.1. These trees are protected by the CEZ or Construction Exclusion Zone. **T46, T51, T52** have been identified for removal due to poor condition and or defects. Please see schedule 2.1 for condition details. Planting of replacement trees is specified in schedule 2.1 and specified in the landscaping plan prepared by Lingard Farrow Styles that will accompany the planning application. This has been implemented in order to preserve the stand amenity for the future, enhance age structure, bio-diversity and resilience into the future.

Southerly stand of trees including G2, looking from the north. Poor condition trees to be removed as per schedule. 2.1. Retained trees to be protected in accordance with BS:5837/2012 and stand to be beaten up with additional planting to mitigate tree removals. Include T42-T52.

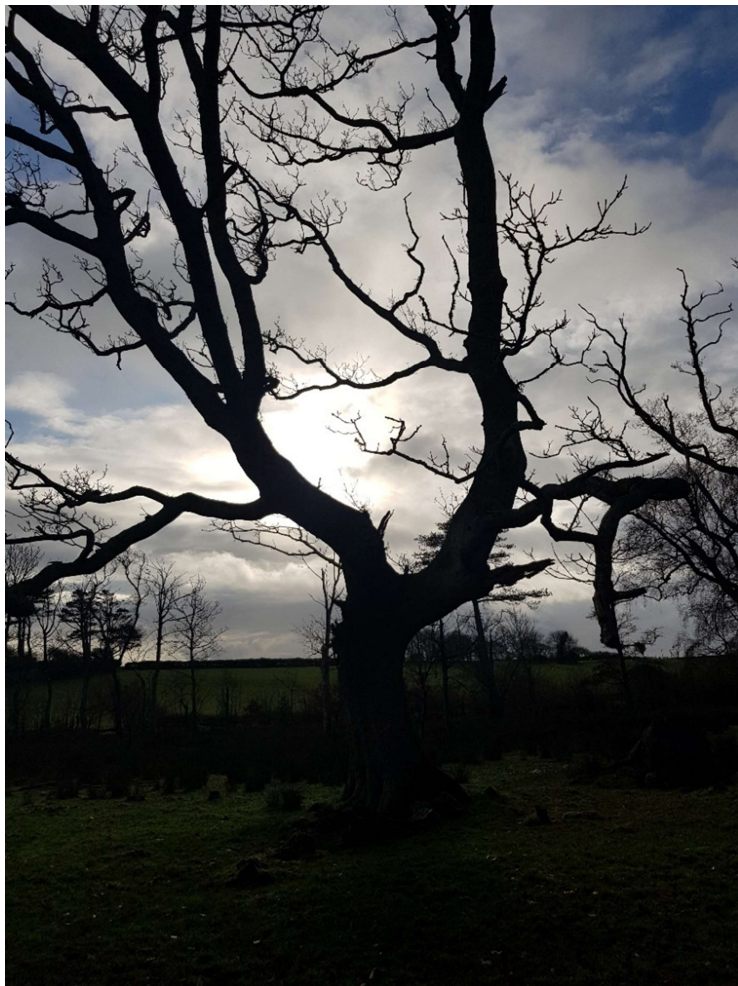
T53

**T53, T54, T55 and T56 located to the far west of the site are to be retained.** These trees are high amenity, overmature and of veteran status and are of **C** and **A** BS:5837/2010 classification. These veteran trees are to be sectioned off around perimeter of crown, post construction with post and rail fencing outside of the rooting zone and left to their own devices. **T55** has also been identified as having a bat roost. These trees are situated some distance from the proposal and therefore will not be impacted upon and can be monitored for condition under BS:3998/2010 into the future. These trees are to be protected during construction with protective fencing in accordance with BS:5837/2012. Tree works should be carried out in accordance with the schedule 2.1. These trees are protected by the **CEZ** or Construction Exclusion Zone.
