LAND ON A497 AT BRON EIFION, CRICCIETH, GWYNEDD, LL52 0RR
GEOTECHNICAL, GROUND PERMEABILITY AND CONTAMINATION INVESTIGATION REPORT

Project Title : LAND ON A497 AT BRON EIFION, CRICCIETH, GWYNEDD, LL52 0RR

Document Title: GEOTECHNICAL, GROUND PERMEABILITY AND CONTAMINATION INVESTIGATION REPORT

Project No. E1125
Report No. E1125.GGCI.R1
Date. JUNE 2020

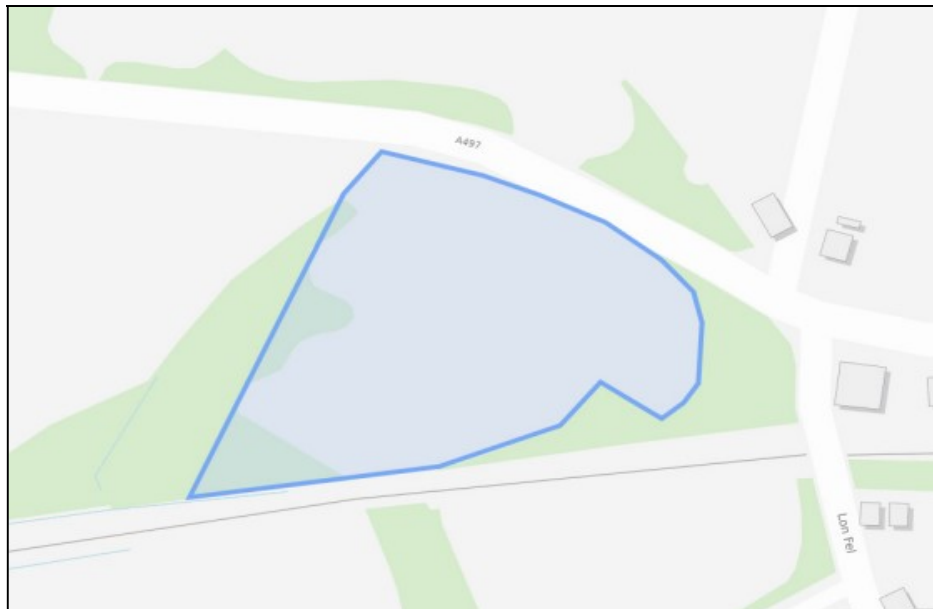
Figure 2 – Site Extent

- 2.1.2 The extent of the site and the study area boundaries is shown on Figure 2.

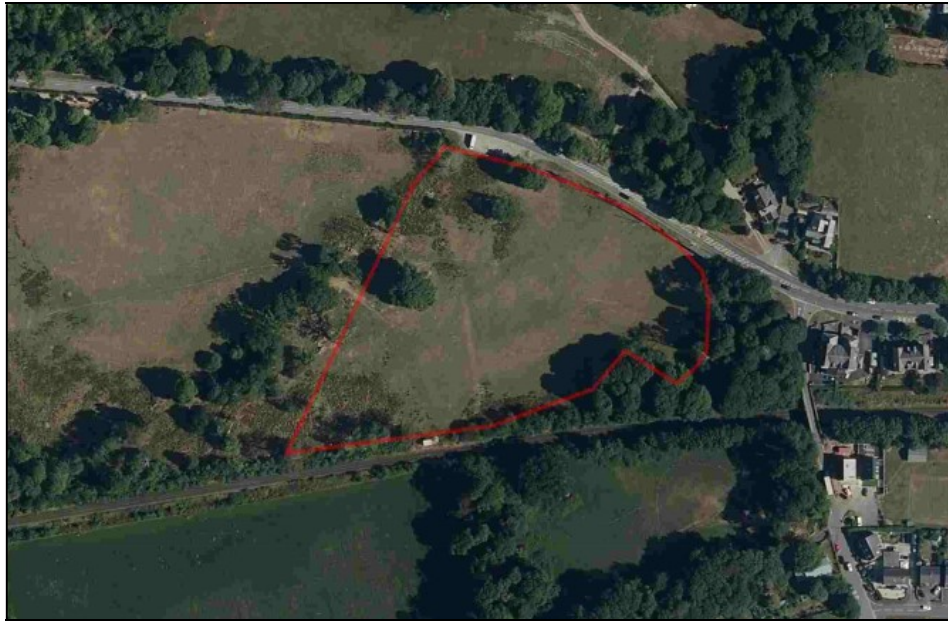
Figure 3 -Aerial Photograph

- 2.2.1 The area for investigation (site) presently comprises grassed agricultural land used for grazing, to the south of the A497 and between the main road and Criccieth to Pwllheli railway line. The site is slopes gently towards the south and the railway line which forms the southern boundary. There are no structures on the site. An aerial photograph of the site area is shown as Figure 3.
