**BS: 5837/2012. Tree Impact Assessment. – Ysgol Treferythyr Criccieth, field south of the A497, Llanystumdwy, Criccieth, Gwynedd, Wales, LL52 0RY.**

**Report Prepared By: L O'Connor BSc (Hons), MSc.**

**18/05/2021.**

## **TREE IMPACT ASESMENT. (T.I.A.).**

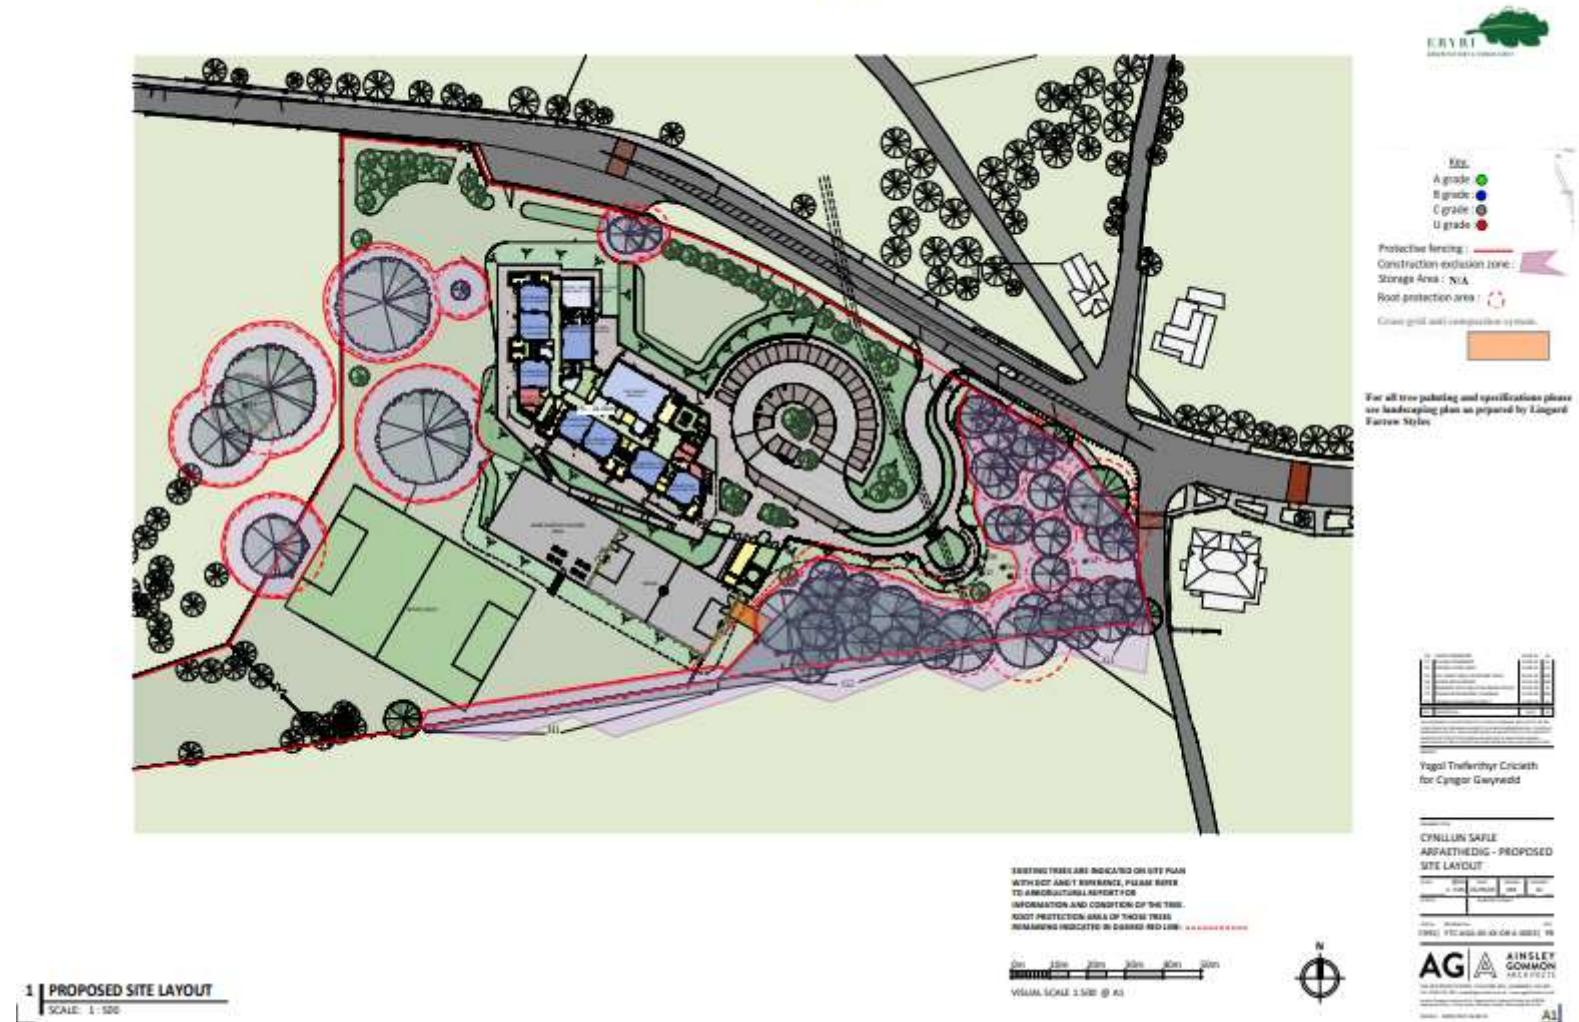
FIG.TCMAPP.9. Ysgol Trefferthyr.

**T13, T15, T17, T21, T22, T29, T32, T34, T35, T37, T38, T39, T59 & G1 located to the far east of the site are to be removed.** The trees have been identified for removal due to poor condition and or defects. Please see schedule 2.1 for condition details.

**T42, T43, T44, T45, T47, T48, T49, T50** Are to be retained and are situated within **G2** at the south of the site. These trees are classified as **BS: 5837/2012 Category A and B trees.** These trees are to be protected during construction with protective fencing in accordance with BS:5837/2012. Tree works should be carried out in accordance with the schedule 2.1. These trees are protected by the CEZ or Construction Exclusion Zone. **T46, T51, T52** have been identified for removal due to poor condition and or defects. Please see schedule 2.1 for condition details. Planting of replacement trees is specified in schedule 2.1 and specified in the landscaping plan prepared by Lingard Farrow Styles that will accompany the planning application. This has been implemented in order to preserve the stand amenity for the future, enhance age structure, bio-diversity and resilience into the future.

**T53, T54, T55 and T56 located to the far west of the site are to be retained.** These trees are high amenity, overmature and of veteran status and are of **C** and **A** BS:5837/2010 classification. These veteran trees are to be sectioned off around perimeter of crown, post construction with post and rail fencing outside of the rooting zone and left to their own devices. **T55** has also been identified as having a bat roost. These trees are situated some distance from the proposal and therefore will not be impacted upon and can be monitored for condition under BS:3998/2010 into the future. These trees are to be protected during construction with protective fencing in accordance with BS:5837/2012. Tree works should be carried out in accordance with the schedule 2.1. These trees are protected by the **CEZ** or Construction Exclusion Zone.
